# Manhole Inspection Summary

Manhole # S29M1\_007MH

Insp Date: **3/12/08 11:27 AM**

**Location** Address: **2524 Round Road**

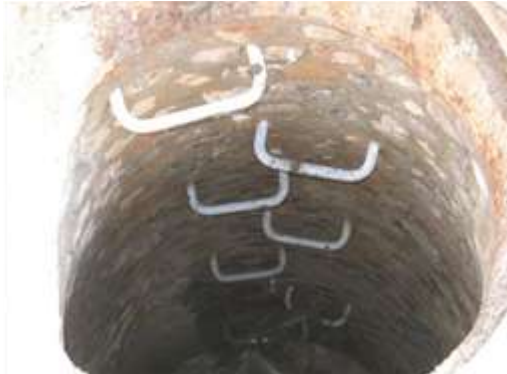
Steps

**Steps** Count: **7** Missing: **0** ☐ Corroded

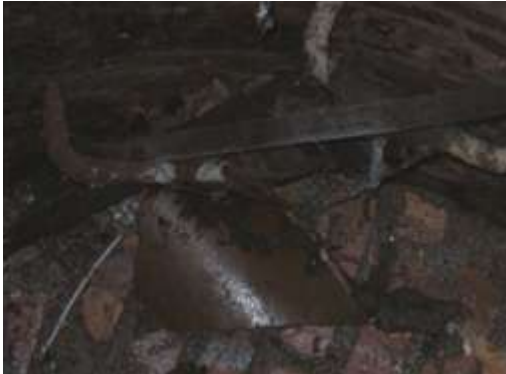
Defect 1

Step

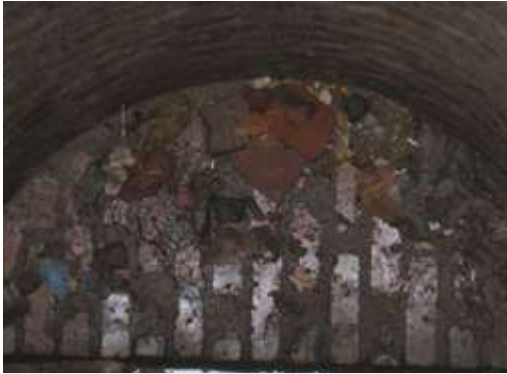
Defect 2

Debris

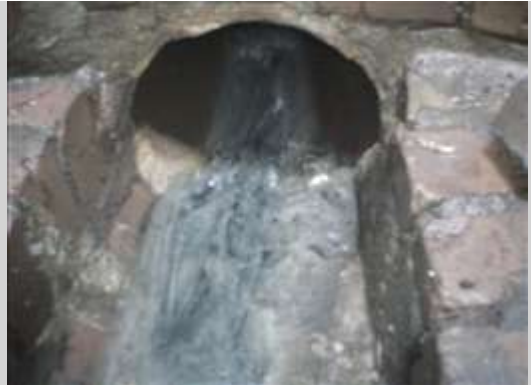
12 O'Clock Outflow

8 in. Circular Gravity Sewer  
Pipe Out @ 12 O'Clock

Pipe Height: **10.8** (in.) Rod and Bar (Angled)  
Pipe Material: **Clay** ☐ Pipe Lined  
Invert Depth: **11.42** (ft.) Flow Characteristics: **Fast**  
Deposits: ☒ None ☐ Mud ☐ Sludge ☐ Debris ☐ Grease  
Silt Depth: (in.) Deposits Extent:  
Infiltration: **None** Pipe Seal Cond: **Sound**

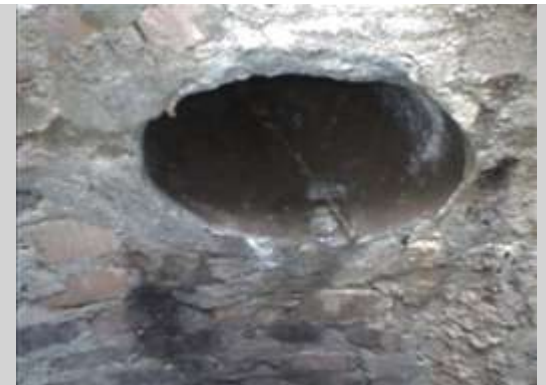
6 O'Clock Inflow

6 in. Circular Gravity Sewer  
Pipe In @ 6 O'Clock

Pipe Height: **9.6** (in.) Rod and Bar (Angled)  
Pipe Material: **Clay** ☐ Pipe Lined  
Invert Depth: **7.29** (ft.) Flow Characteristics: **Fast**  
Deposits: ☒ None ☐ Mud ☐ Sludge ☐ Debris ☐ Grease  
Silt Depth: (in.) Deposits Extent:  
Infiltration: **None** Pipe Seal Cond: **Sound**

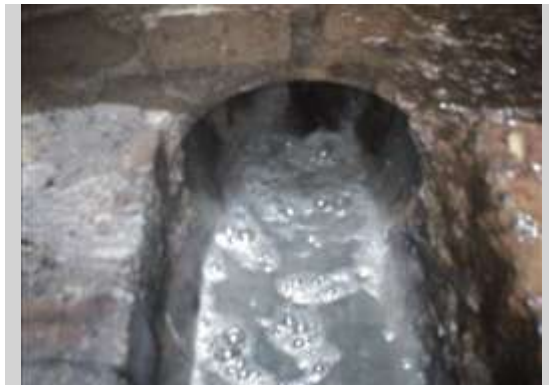
Drop In @ 6 O'Clock

Drop: **Outside** Rod and Bar  
Angled: **Yes** Reading: **10.40** (ft.)  
Inv Depth: **11.40** (ft.)  
Drop Condition: **Open**
